MAJ Enterprises Presents from Cognex

Image-Based Scanner Boosts Read Rates from 93% to 99.9%, Saving Meat Plant Time and Money

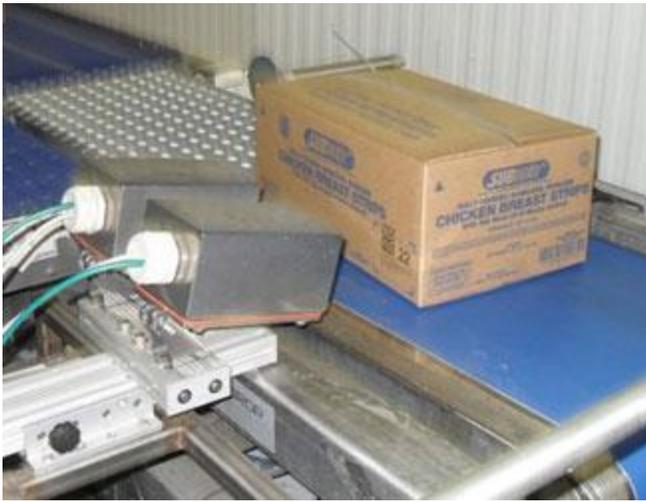
The DataMan 500 acquires an image of the entire box and locates the code regardless of its position and orientation so the position and orientation of the barcode no longer matters. The code can be printed directly on the box, which saves time by eliminating the need to manually apply a label to each box. The code can be positioned anywhere on the box, making it possible to meet customer requests to put the code in a specific position. The DataMan 500 automatically records failed images and stores them on a server. West Liberty engineers can look at the images to see why they failed. This provides a troubleshooting capability that reduces the time required to resolve code printing issues.
